# RESIDENTIAL FIRE SPRINKLERS RETROFIT DEMONSTRATION PROJECT

Final Report

Phase II:  
Single-Family  
Structures

**RESIDENTIAL FIRE SPRINKLERS  
RETROFIT DEMONSTRATION  
PROJECT**

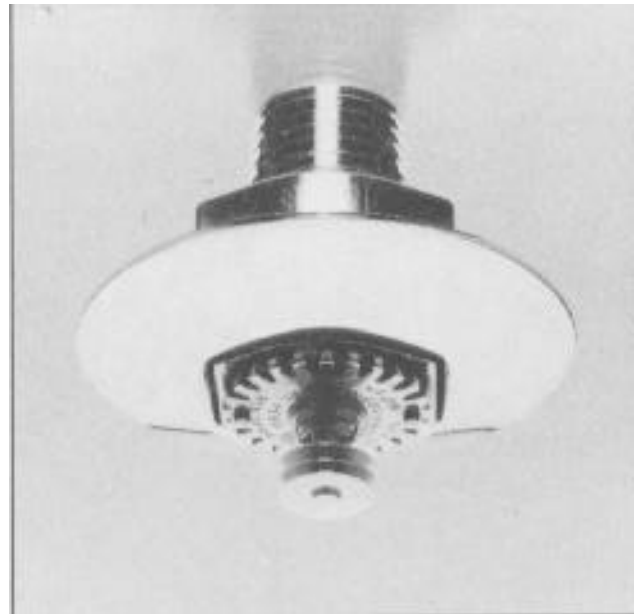
Figure 1. Typical Quick Response Pendent Sprinkler Head for Residential Applications. (Courtesy of the Central Sprinkler Company).

The “quick response” sprinkler heads used in all these installations and required by NFPA-13D differ from commercial sprinkler heads in the properties of the fusible element. The time required for the sprinkler head to be exposed to the activation temperature before flow is initiated has been significantly decreased in quick response heads. Also, the physical appearance of the residential heads is designed to be less obtrusive. Figure 1 shows a typical quick response head for residential installations. Most sprinkler head manufacturers now offer quick response heads for residential and light commercial applications. The design premise of NFPA-13D residential fire sprinkler systems utilizing quick response heads is to control incipient fires in the room of fire origin for up to 10 minutes.
